ILJS-24-097 (SPECIAL EDITION)

Geological, Geotechnical and Geophysical Investigation of Gully Erosion in Ilorin, Kwara State Nigeria

Amao P. A.,¹ Ige O. O., and Olaleye I. M.

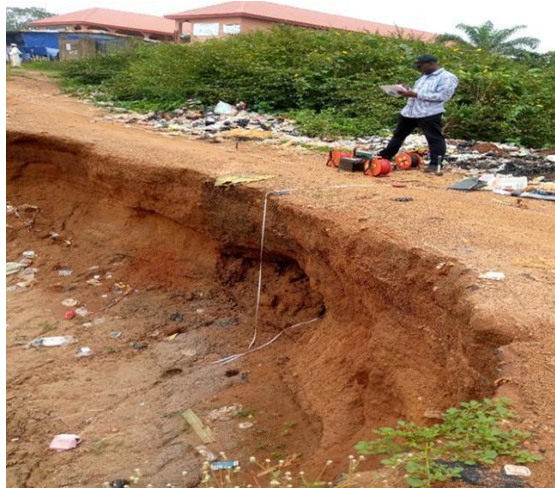
Plate 1: Geophysical Investigation at Amoyo gully erosion site in Ilorin

1D Vertical Electrical Sounding (VES) and 2D resistivity imaging were used to analyze subsurface erosion-related characteristics. Data was acquired using ABEM's Terrameter SAS4000 and processed with WINRESIST software, providing insights into subsurface lithology, stratigraphy, and groundwater levels.

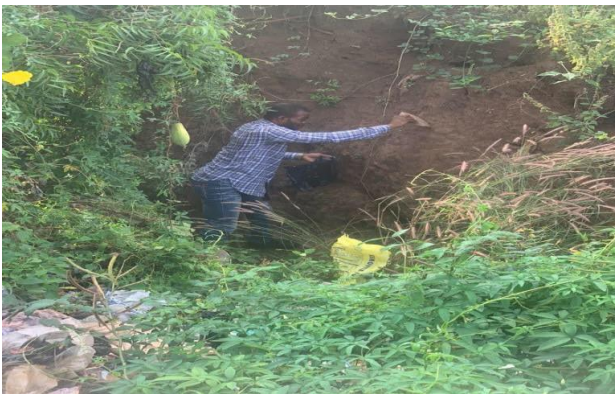
Plate 2: Sample Collection on the 2nd Lithology

The soil samples were collected systematically at each gully sites. The gully wall was divided into three lithologies (Upper layer, middle layer and the lower layer) based on their physical appearances and soil samples were taken on each layer making 3 soil samples at each location, summing up to a total number of 39 soil samples at 13 gully sites spread across Ilorin town. The soil samples were obtained incipient gullies at depths of 1.8m and 4.5m. The soil samples were wrapped in a sack and labelled accordingly.

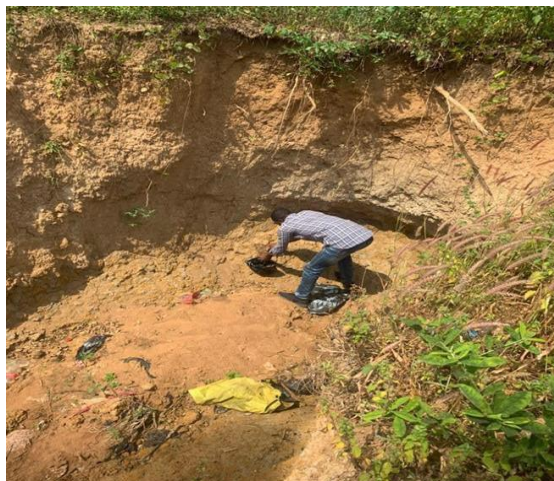
Plate 3: Sample Collection on the 2nd lithology

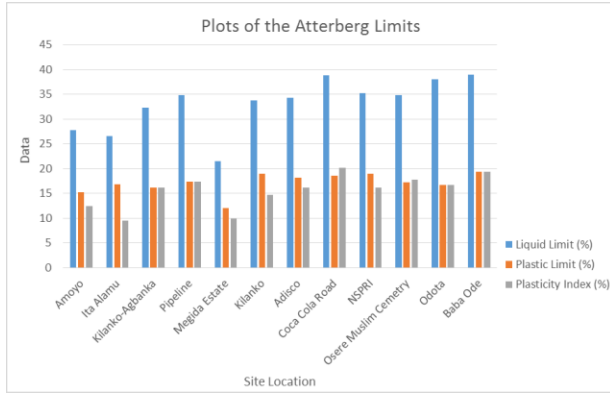
Figure 1: Bar Chart plot of the Atterberg Limits

Soil samples from gully sites are predominantly sandy, with sand content ranging from 20-85% (mean: 40.6%). The soils are classified as medium to coarse-grained, with uniformity coefficients (cu) from 3.5 to 18.9 and curvature coefficients (cc) from 0.5 to 3.4. Fines include silt (2-11%, average: 6.9%) and clay (3-46%, average: 19.1%). Liquid limits (LL) range from 19.0-50% (mean: 32.8%), and plasticity indices (PI) range from 9.3-

27.3% (mean: 15.7%). These characteristics reveal that the soils are primarily loose sands with low fine fractions, making them cohesionless and susceptible to gully erosion.

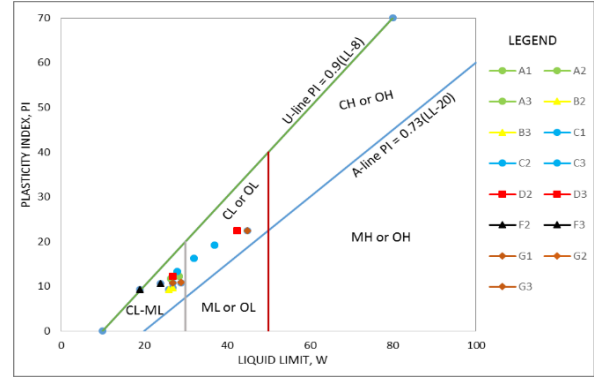
Figure 4: Plasticity chart of soil samples

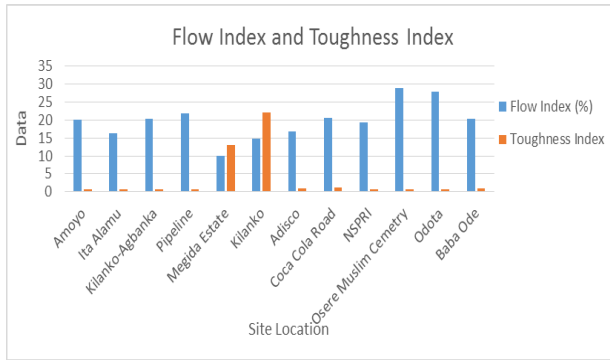
Figure 2: Bar Chart plot of Flow Index and the Toughness Index of the Gully sites.

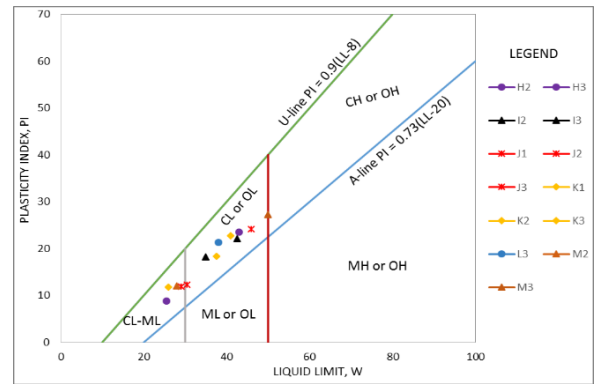
Figure 5: Plasticity chart of soil samples

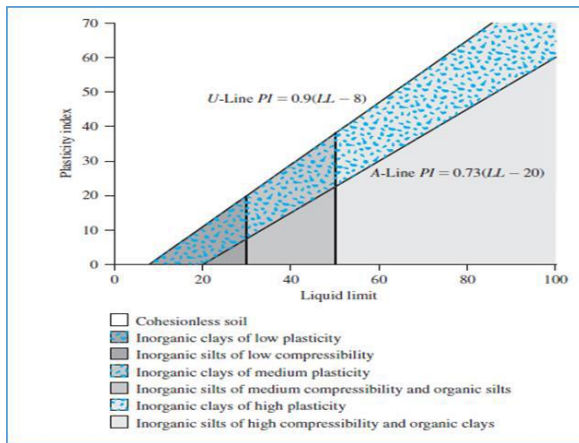
Figure 3: Plasticity chart, USCS (Das, 2010)
